# *Juneau Airport Wind System (JAWS) Wind Sensor Severe Weather Performance Test Report*

August 2002

DOT/FAA/CT-TN02/18

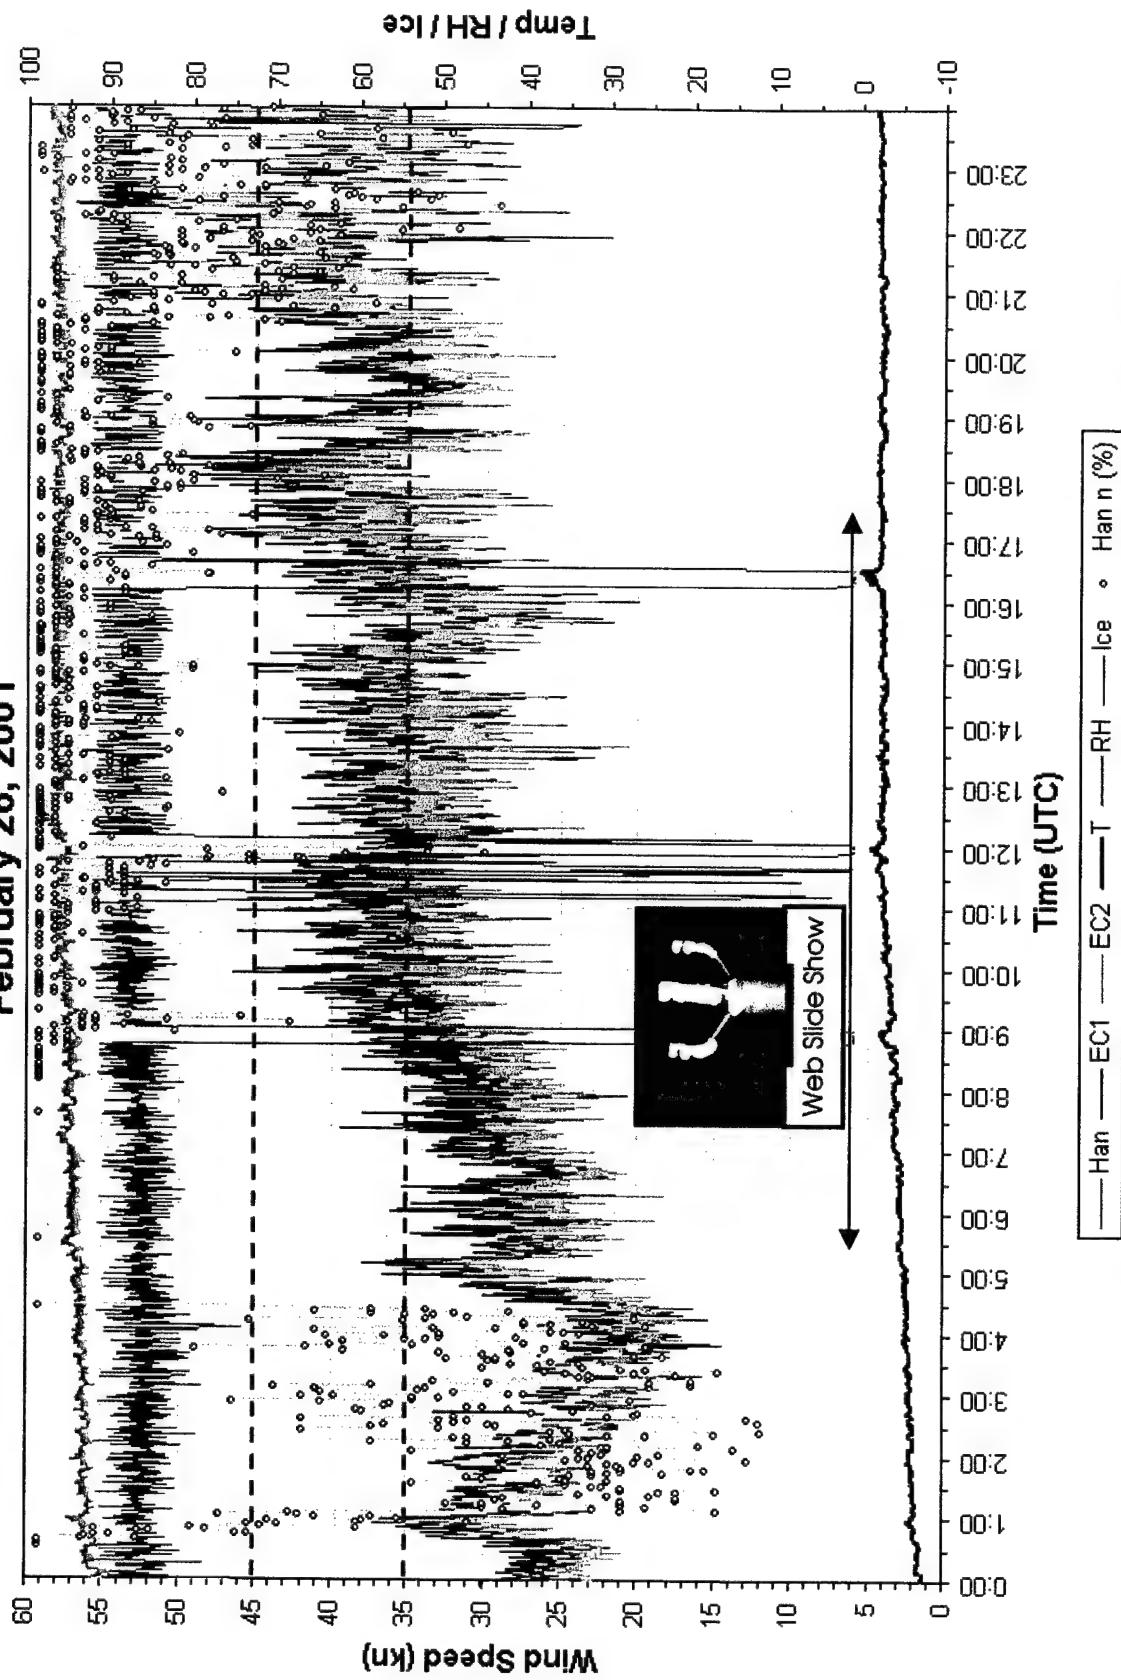
Closer inspection was performed to determine the validity of the affected 1-minute average values when ice was apparent on the anemometer. Time series of Vaisala wind speed and direction values during significant icing events are depicted in figures 71 through 77. In these figures, the sample size of valid data, in percent, comprising the 1-minute averages is shown in yellow against the secondary ordinate axis.

FIGURE 74. VAISALA 1-MINUTE WIND SPEED AVERAGES DURING AN ICING EVENT

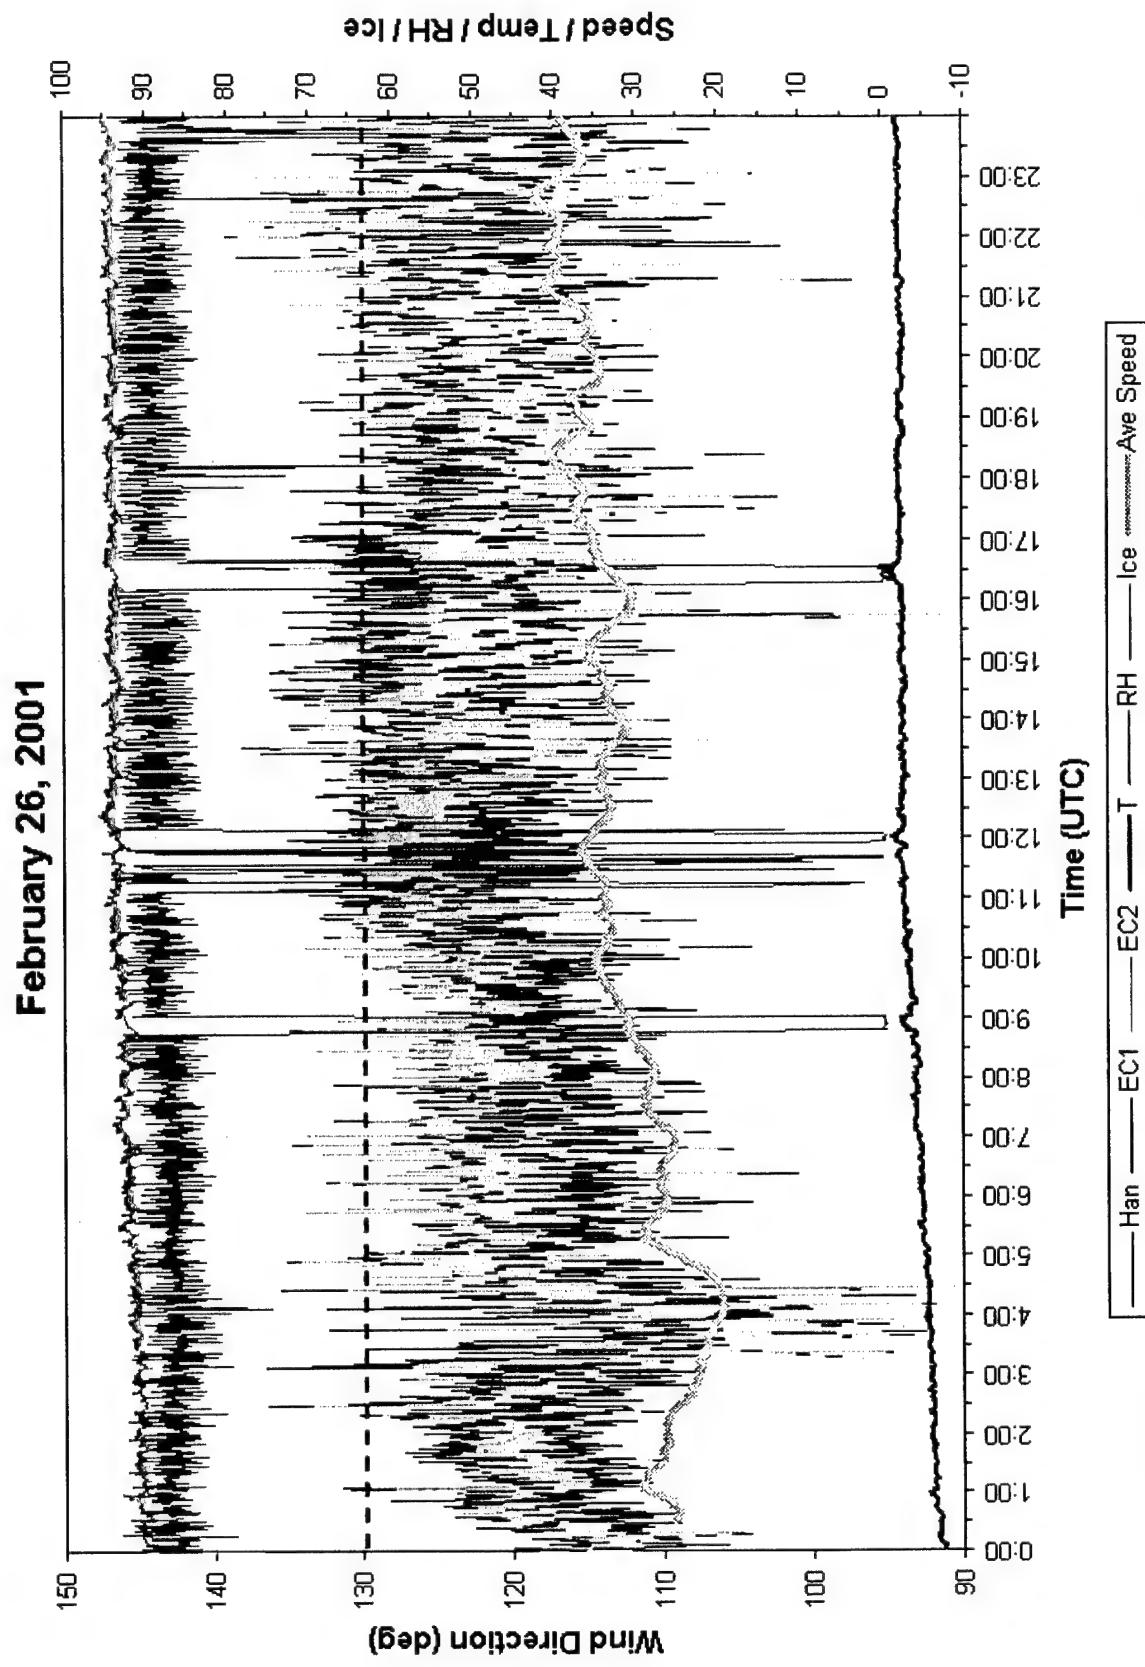
FIGURE 75. VAISALA 1-MINUTE WIND DIRECTION AVERAGES DURING AN ICING EVENT

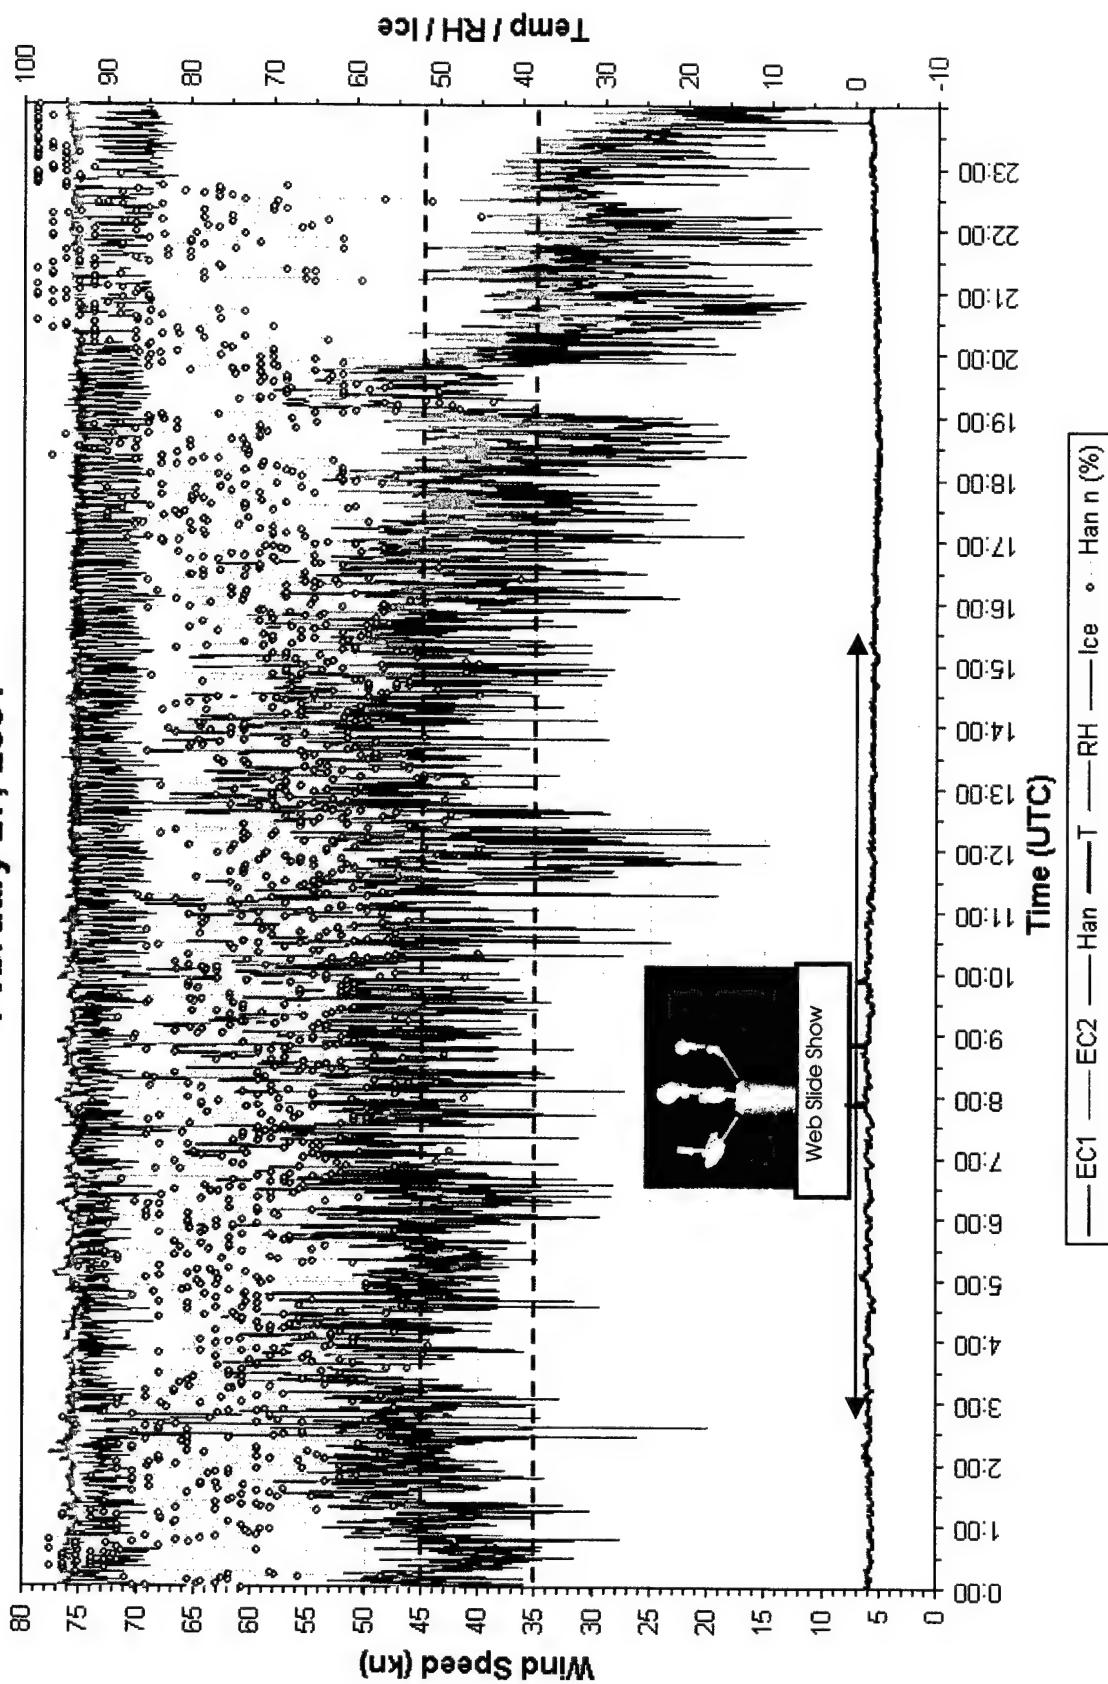
FIGURE 76. VAIISALA 1-MINUTE WIND SPEED AVERAGES DURING AN ICING EVENT

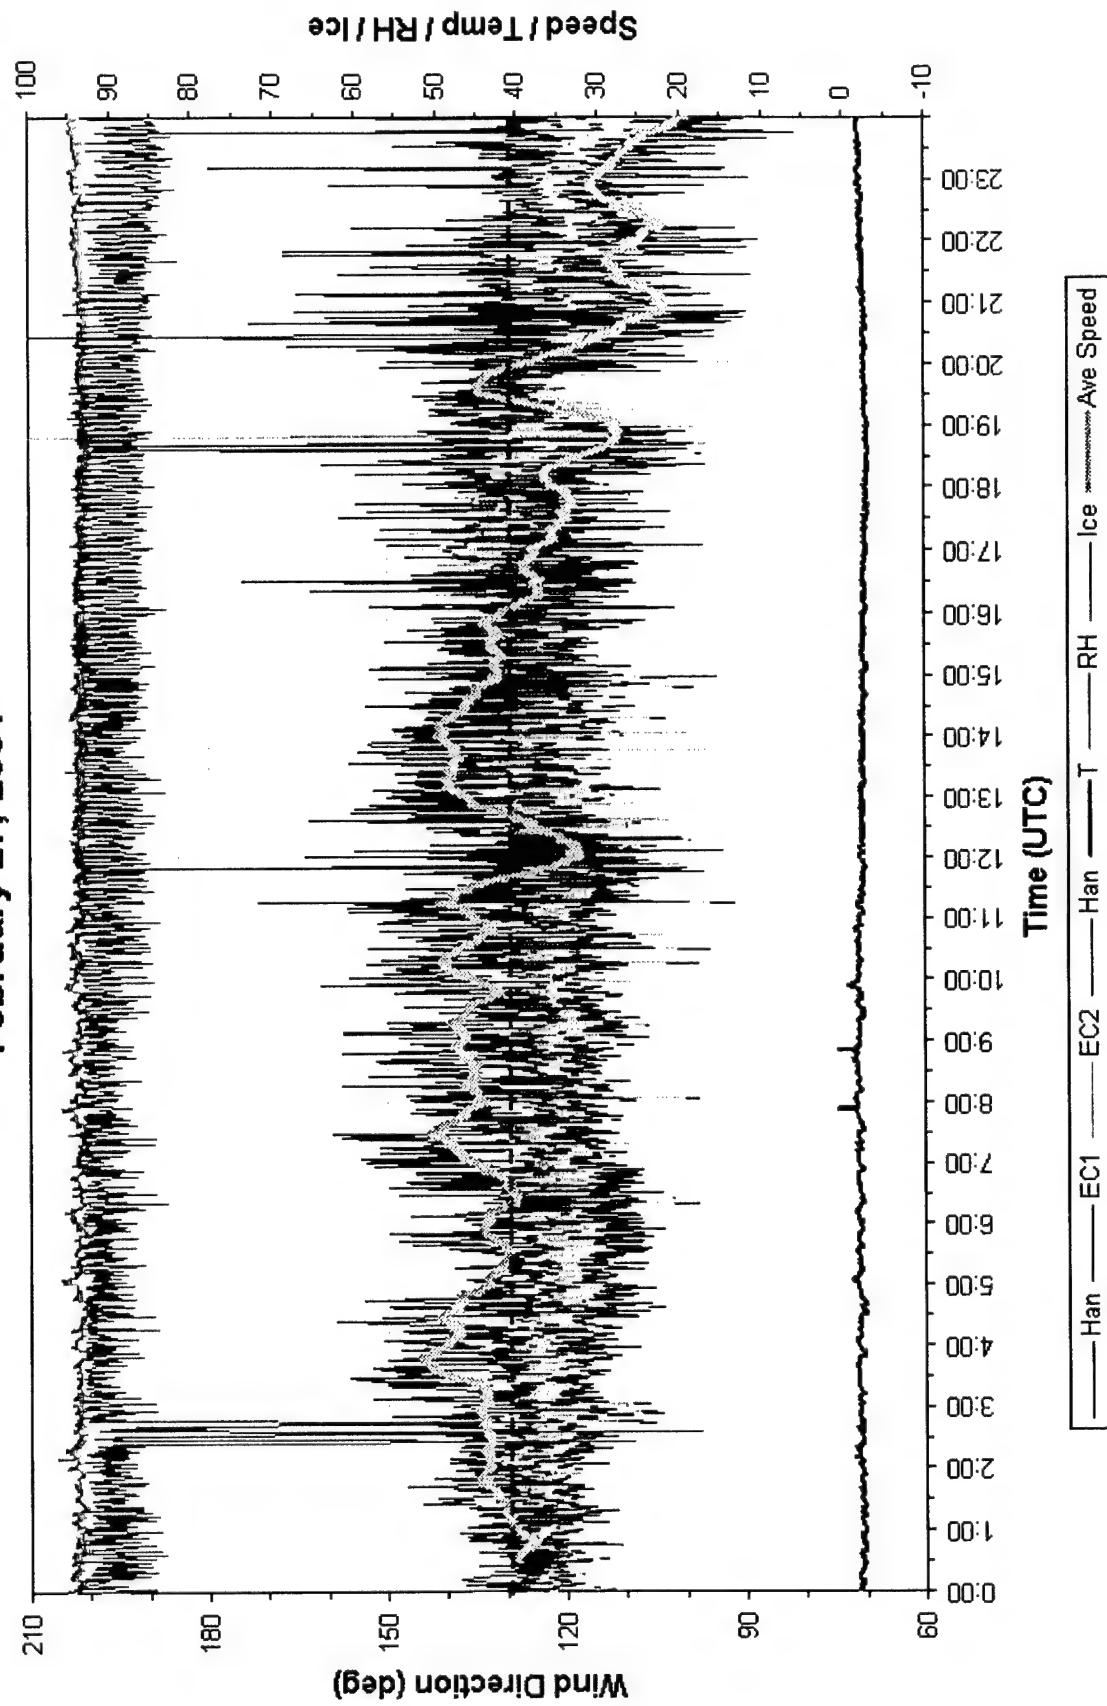
**FIGURE 77. VAISALA 1-MINUTE WIND DIRECTION AVERAGES DURING AN ICING EVENT**

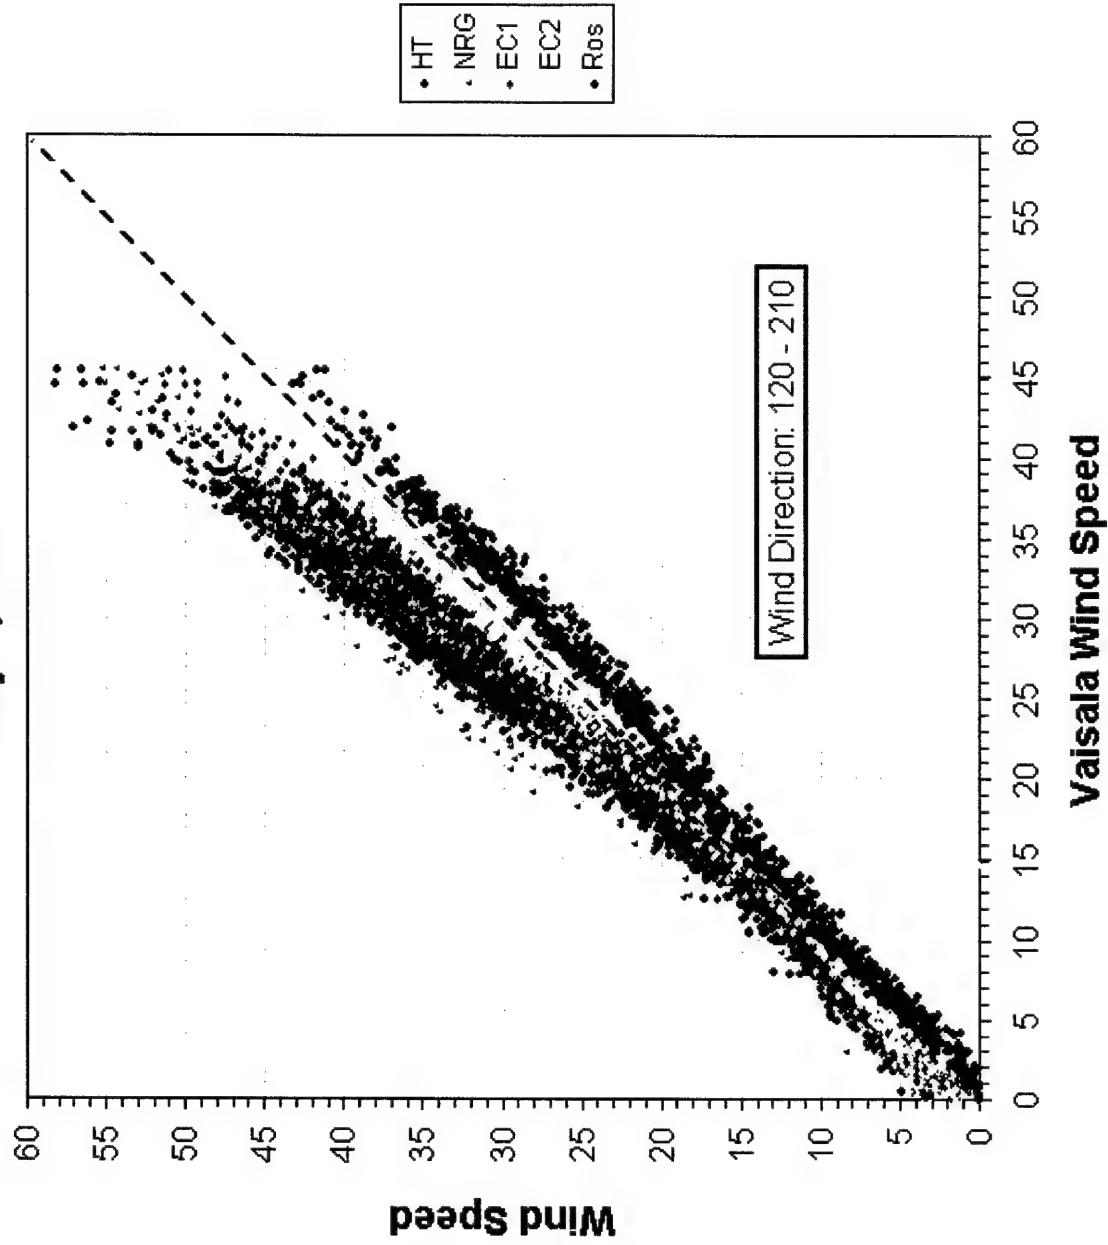
The Rosemount 1774W pressure-type probe exhibited optimistic performance as shown in figure 78. However, the sensor was installed late in the season and the resulting data set was unfortunately limited.

FIGURE 78. WIND SPEED DISTRIBUTION FOR SOUTH WIND
